TRANSPORTATION SAFETY

REFLEXIONS

Issue 27 – March 2004

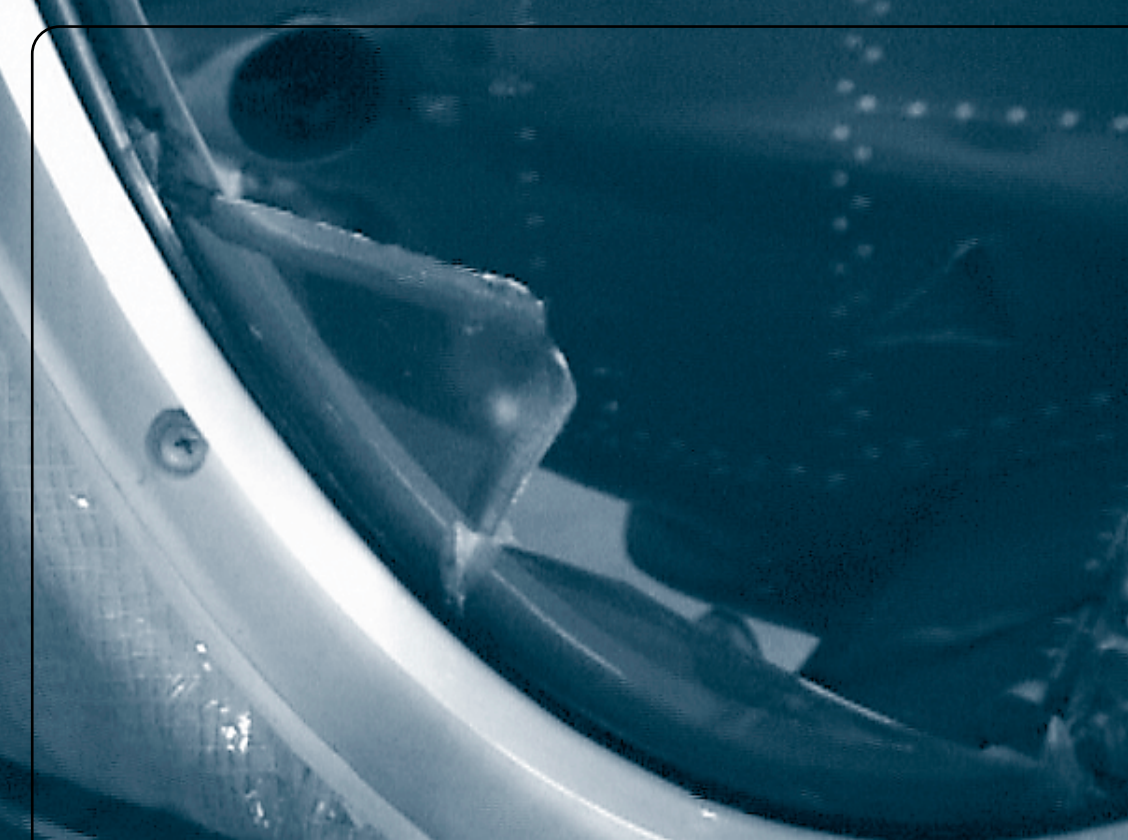
Non-adherence to standard operating procedures following a rapid decompression put the crew and passengers in a Beech 1900D airliner at unnecessary risk. – [TSB Report No. A02A0046](#)

Examination of the aircraft showed that most of the right cabin emergency exit window and a piece of the interior window trim were missing, with only small window fragments still attached to the window seal. The failed window fragments and the two right side

forward cabin windows were removed and sent to the manufacturer for further examination. Two of the fragments contained the area of the plastic side window that protruded beyond the rubber seal and was exposed to the environment in a similar manner as the two forward side windows. All the cracked edges appeared to be the result of secondary cracking failures propagating from the original crack failure. Both pieces had surface chip gouges on the exterior surface between the rubber seal and the cracked edge. The chip gouges measured 0.022 inches deep by 0.050 inches wide and 0.028 inches deep by 0.075 inches wide.

It appears that at some time during the aircraft's operating history, a take-off was conducted from a runway surface that had excessive debris on it, and this debris was blown against the windows by the right-hand propeller, causing surface gouges. With only small fragments from the failed window available for examination, the exact cause of the window failure could not be determined. However, these fragments and the adjacent windows had surface chip gouges in excess of the recommended tolerance and some of the gouges had cracks protruding internally. Therefore, it is probable that a cracking failure occurred due to the extensively damaged condition of the exterior surface of the window.

Prior to this incident, the operator measured window surface damage with a needle tip dial indicator. During laboratory testing, Raytheon used a 966A1 Optical Micrometer and a SPI scale comparator. Labrador Airways has since purchased an optical micrometer for window inspections. In tandem with this, a Quality Assurance Bulletin was issued changing the inspection schedule from 1200 hours to 200 hours; the bulletin also states that any window with questionable limits is to be replaced before flight.

As a safety action, the operator has replaced the three forward side windows on both sides of the aircraft with multi-ply windows.

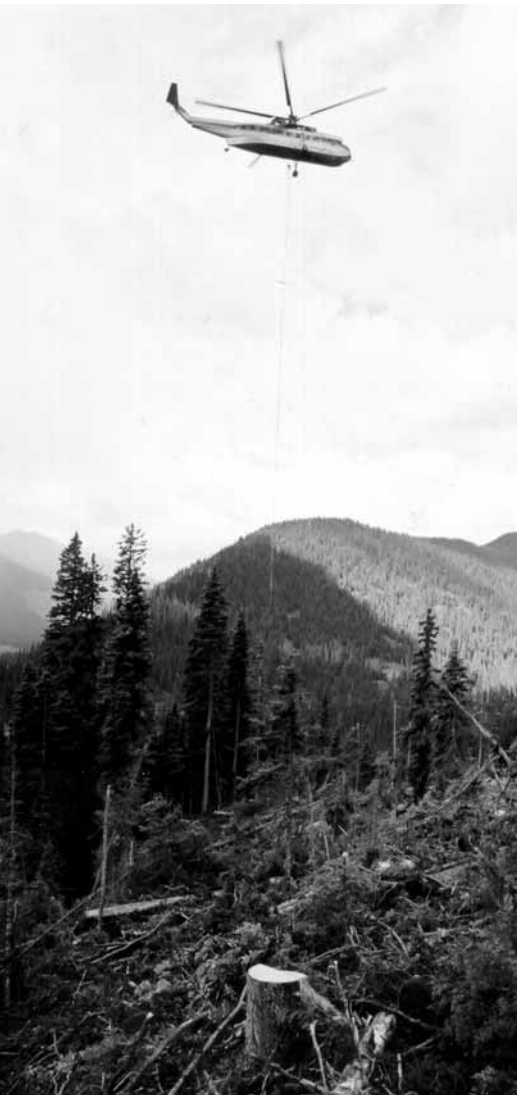
Sikorsky S-61 using a longline to pick up logs

The left and right IFWUs had been overhauled by the operator, Croman Corporation, on 12 September 2001, using new camshafts, roller retainers, rollers, supports (oilites), gear housings and gear housing bearings. At the time of the accident, the IFWUs had accumulated 532 hours, which is within the recommended time between overhaul (TBO) of 500 ± 50 hours for IFWUs used for repetitive external lift (REL) operations (this TBO had been recommended by Sikorsky as a direct result of the finding of increased IFWU wear in REL operations noted in TSB Report No. A93P0051). Following the accident, the IFWUs were disassembled, inspected, and several component parts were tested. The right and left IFWUs exhibited similar wear and damage.

Metallographic examination of the area around flat spots on the rollers showed an untempered martensite surface layer. Skidding and spit-out of the rollers is the most likely cause of these metallurgical anomalies. The rollers were

not through-hardened to the required specification during their manufacturing process. It is not known what effect this defect may have had on the IFWU's ability to maintain engagement. Wave-shaped areas of raised metal on the camshaft flats on the low (disengaged) side of the roller impressions indicate that the rollers were forced in the disengaged direction with extreme and unusual force. Other damage to the IFWU components—smearing of the roller metal, denting and pitting of the gear housing roller path, and breakup of the oilites—is also indicative of damage caused by slipping and spitting out.

Damage to the oilites can cause a loss of support to the roller retainer. This in turn can cause a loss of alignment of the rollers, which increases the likelihood of roller spit-out. During normal operation, the oilites are stationary and do not carry a load. However, a quantity of fine bronze particles was found in the oil, indicating that the oilites were subject to repeated small loads and motions, such as would occur as the result of vibration. Contamination of the roller path with oilite material increased the likelihood of roller spit-out.
